Handling crane accidents and emergencies

Larry Lam, SC Tok, Peter Darley, Portek International Ltd, Singapore

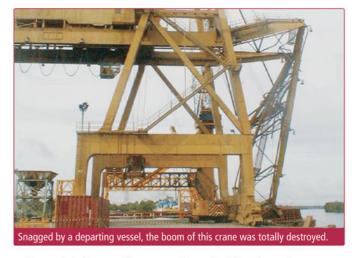
Even a brief impact from a vessel can significantly weaken a crane structure – even when little apparent external damage can be seen.

The damage caused by a ship snagging a crane boom (in 'boom down' position) is especially vicious. This is due to the fact that when a vessel catches the forward tip of the crane boom, it is essentially using a lever with a long arm – thus multiplying the force. The tremendous force twists all of the main components of the structure, and in extreme cases, the crane will collapse.
